Bank Stabilisation Works, West Dilston

Scope of Works

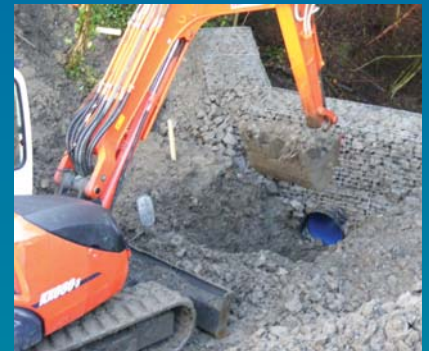
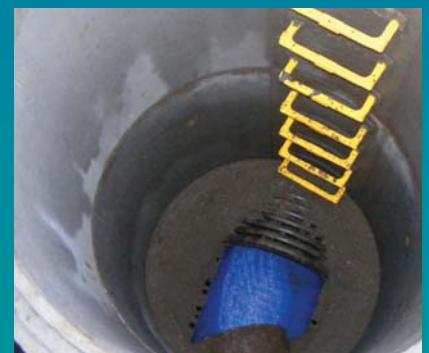
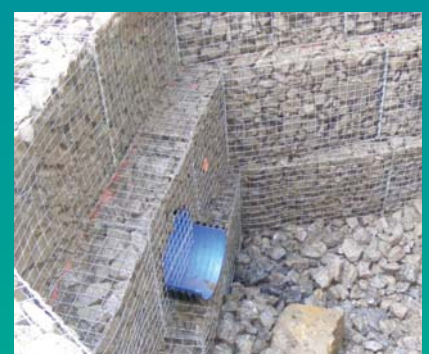
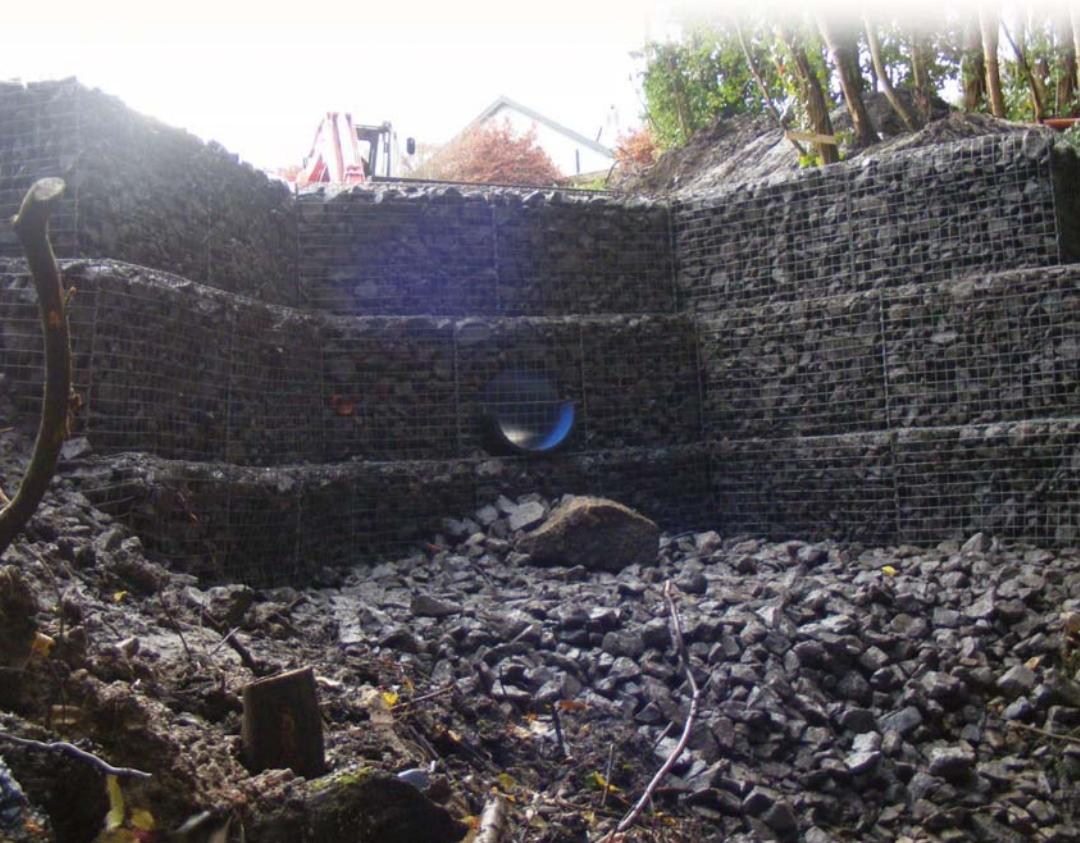
The scheme required the investigation of a bank slip which was encroaching towards two domestic properties on site, followed by excavation and stabilisation of the bank using engineered fill materials. An existing dilapidated culvert was replaced with a new twin-wall culvert and gabion headwall.

- Felling and clearance of trees and vegetation.
- Construction of 3 metre high 'gabion' headwall and outfall to retain new embankment.
- Excavation of slip, importation of coarse sandstone fill material and filling and compaction to stabilise bank.
- Installation of new 600mm diameter culvert 'diversion' c/w chambers.
- Re-connection of drainage pipe work damaged by land slip.
